NASA TECHNICAL MEMORANDUM 102676

**OPEN HOLE AND POST-IMPACT COMPRESSION
FATIGUE OF STITCHED AND UNSTITCHED
CARBON/EPOXY COMPOSITES**

**M. A. Portanova, C. C. Poe, Jr.,
and John D. Whitcomb**

June 1990

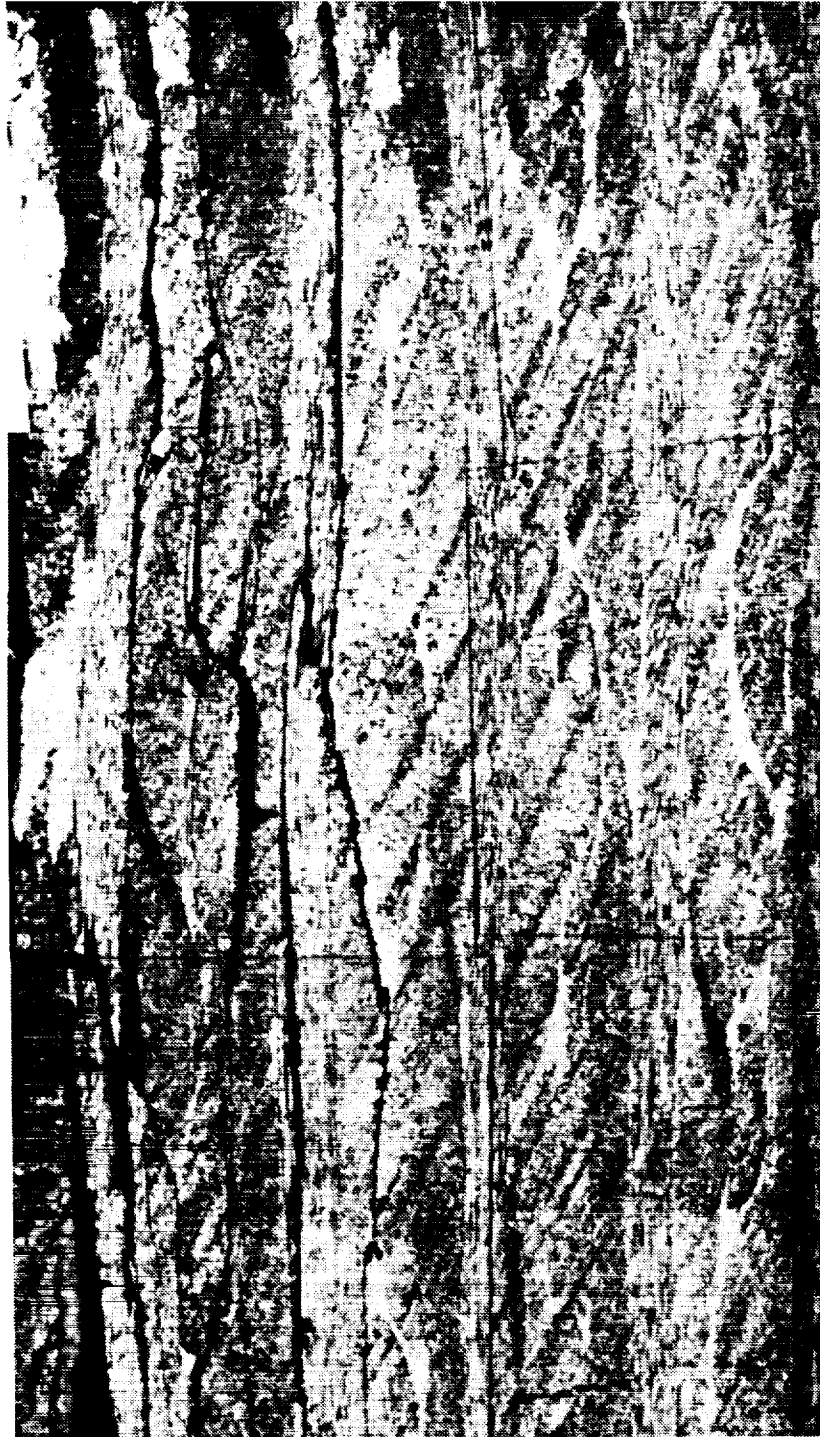
Depth of
Fatigue
Damage
 $\approx 2 \text{ mm}$
(0.08 in.)

Figure 13: Photomicrograph of stitched AS4/3501-6 after 300,000 cycles.
R = 10, 167 MPa Maximum Compressive Stress, 822,000 Total Cycles to Failure

this point in the load history. Figure 13 shows that damage to a depth to 2 mm has initiated at the surface ply free edge within the next 90k cycles. The damage consisted of matrix cracking and delamination. Figure 14 shows that this damage remained mostly unchanged from 300k cycles to 650k cycles, tending to grow only in the vicinity of the surface plies. Although the damage did spread across the width, it did not spread through the thickness until near final rupture. Carbon epoxy materials typically fail under monotonic compressive loading due to matrix cracking and delaminations as well as some fiber breakage [5]. In this material the delaminations were very localized at the hole region and final failure was by shear buckling of the fibers. Others have shown that, although the delaminations start earlier in the fatigue life, they progress at a slow rate in stitched materials [4]. The stitching apparently retards delamination growth by suppressing the opening mode. At some point near failure, matrix cracking and delaminations appear at ply levels well below the surface. This phenomenon can be seen in the photomicrograph in Figure 15, taken at 800k cycles, where failure is only 22k cycles away. The progression of failure in the stitched material is typical of that obtained in tape materials of similar constituents. Thus, stitching does not alter the failure mode of these materials, it only slows its progression.

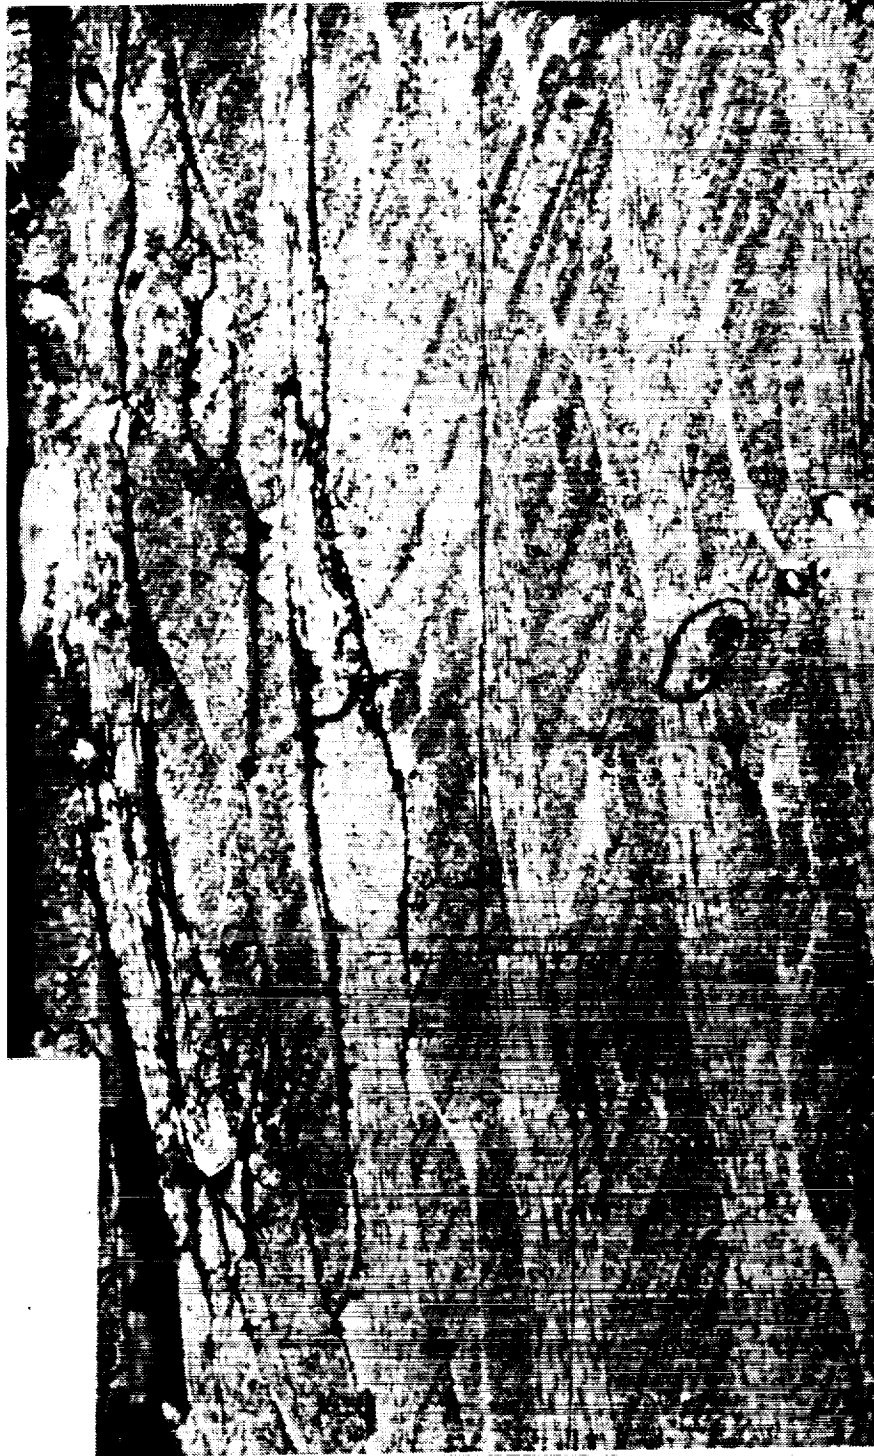
Depth of
Fatigue
Damage
 $\approx 2 \text{ mm}$
(0.08 in.)

Figure 14: Photomicrograph of stitched AS4/3501-6 after 650,000 cycles.
R = 10, 167 MPa Maximum Compressive Stress, 822,000 Total Cycles to Failure

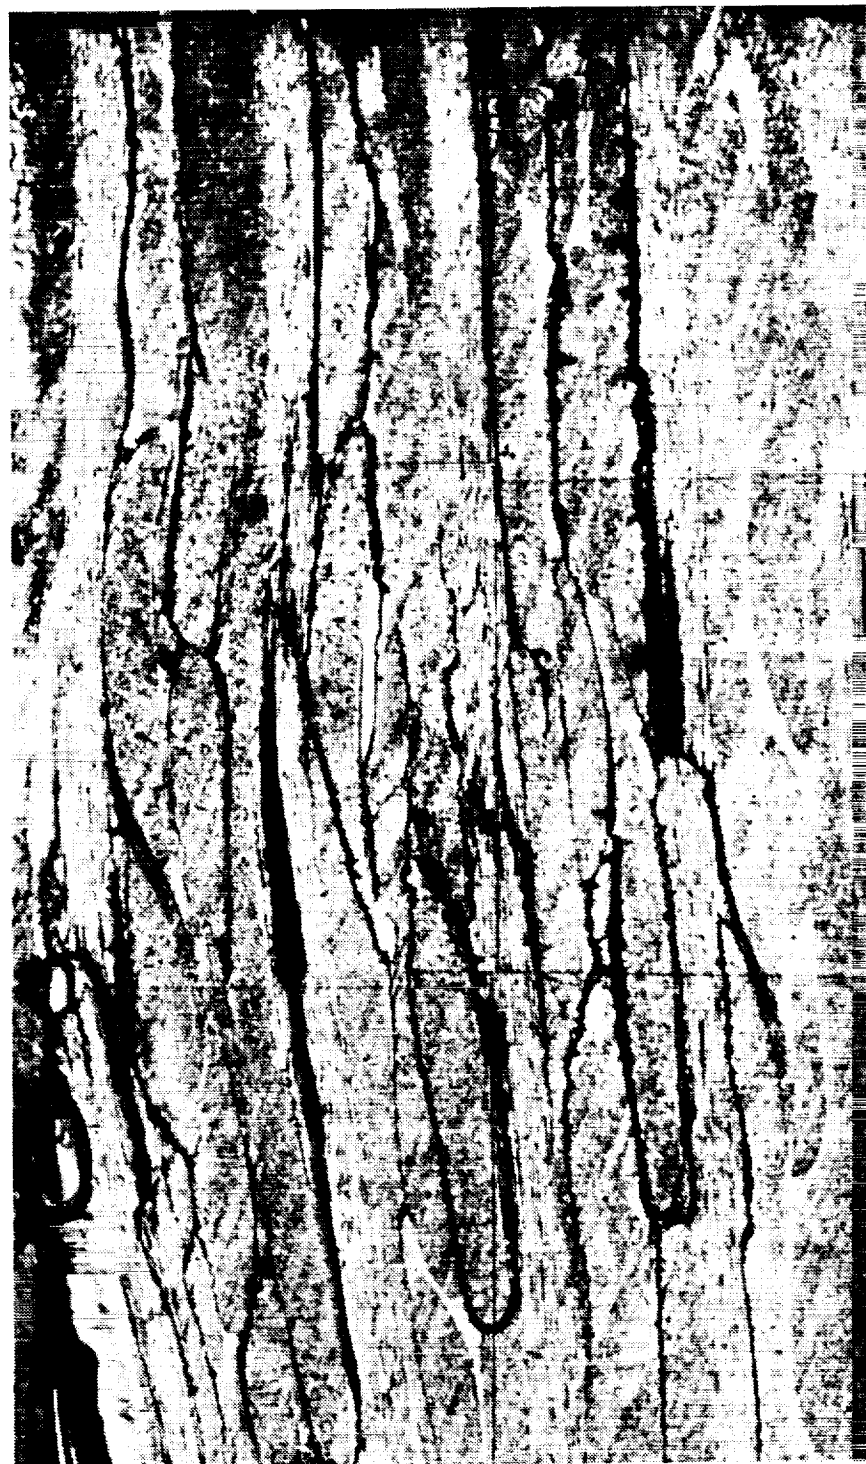
Depth of
Fatigue
Damage
 $\approx 4.5 \text{ mm}$
(0.179 in.)

Figure 15: Photomicrograph of stitched AS4/3501-6 after 800,000 cycles.
R = 10, 167 MPa Maximum Compressive Stress, 822,000 Total Cycles to Failure
